SOUTH-EASTERN AND CHATHAM RAILWAY.

Board of Trade, Railway Department,
8, Richmond Terrace, Whitehall, London, S.W.,
25th March, 1906.

I HAVE the honour to report, for the information of the Board of Trade, in accordance with the Order of the 6th December, 1905, the result of my inquiry into the circumstances attending the fall of part of the roof of Charing Cross Station, on the South-Eastern and Chatham Railway. The fall occurred about 3.45 p.m. on the 5th December last.

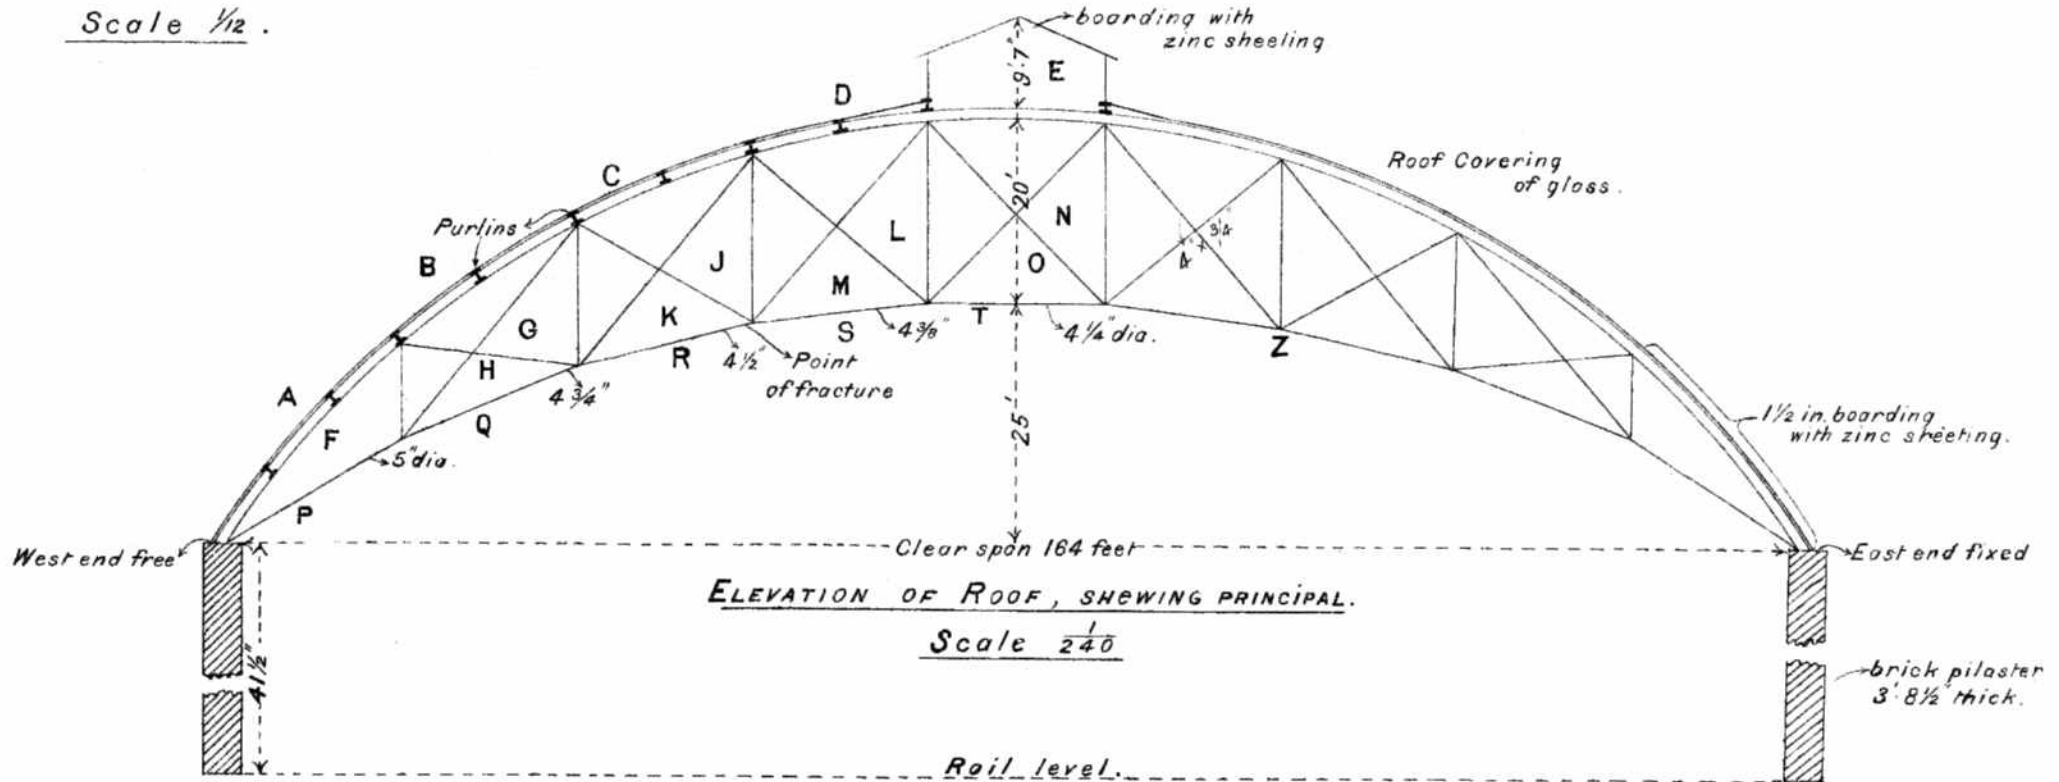
ELEVATION OF ROOF, SHewing PRINCIPAL.

Owing to the great mass and weight of the falling debris, and to the necessity for safeguarding the remainder of the roof, it was not until mid-day on the 9th December that it was found possible (evidence of Inspector Chaplin) to trace the tie rodding of the fallen principal throughout its length. It was then found to be broken at one point only, viz., in the third panel from the west, about 13 inches from the third coupling joint.

The evidence proves beyond a doubt that the snapping of this particular tie-rod was the immediate cause of all that followed. The west wall, without the support of arched buttressing (as in the case of the east wall), yielded eventually to the severe thrust from the loosened bow of the first principal. But the time occupied—12 minutes—shows that not only did the wall offer great resistance to tearing apart, but that much work had to be accomplished in breaking away from the hold exercised on the crippled principal by the lines of purlins, which were stiffened by intermediate lattice girders, and in overcoming the resistance to distortion of the main rib itself.

As regards Charing Cross, the Company have decided to remove the whole of the old station roof, and to replace it by one of the ridge and furrow type, on a lower level, with intermediate supports on the platforms. This work is proceeding, and in the meantime steps have been taken to relieve the tension on the tie-bars of all the remaining principals by taking up some of the strain with wire hawsers.

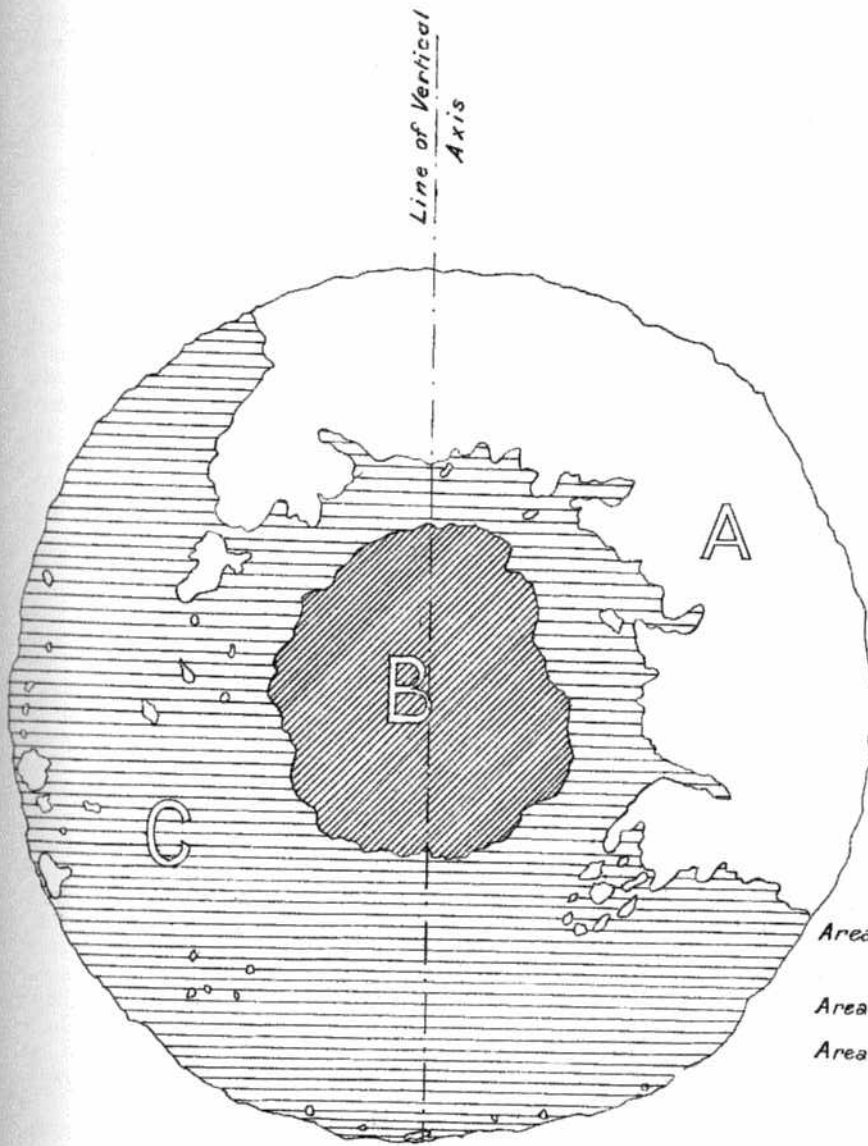
SKETCH OF FRACTURED SURFACE (WEST END) OF TIE ROD.

- Area A - bright crystalline appearance of freshly fractured iron.
- Area B - pocket or original flaw in weld
- Area C - discoloured surface, over which flaw extended.

Turning now to the broken tie-rod, the eastern end in falling buried itself like a bayonet two feet in the ground. This end was unearthed on the 7th December, but the fractured surface was already rusted and corroded, and told no tale. The western end fell on the timbering of No. 2 platform, and was covered with corrugated sheeting and fallen debris. It was thus fortunately preserved from the effects of damp and dirt. I saw it within a few minutes of the time it was uncovered on the 9th December. The surface of the fracture was then as clean and fresh as could be desired. The appearance was typical of a fracture at a badly formed weld. From the sketches (Plate II.) attached, it will be seen that approximately two thirds of the line of fracture is at an angle of about 56° with the axis of the bar, whilst the uppermost third is vertical. The surface of the fracture may be divided for the purposes of description into three parts (*vide* sketch). A belt A about an inch in width (along the vertical line of fracture) extends round the upper and northern half of the circumference of the bar; over this area the fracture had the bright crystalline appearance of iron suddenly torn apart. In the centre of the bar can be seen a flaw or pocket B with a smooth fire-skin surface, surrounded by fragments of dark coloured ash; this area is roughly circular in shape with a diameter of $1\frac{1}{2}$ to 2 inches. The third portion C, mainly consisting of a belt $1\frac{1}{2}$ to 2 inches in width round the lower and southern half of the circumference, was generally discoloured and corroded, with a spongy appearance common in ill-formed welds, but here and there small spots and pin-points, especially round the circumference, of clear crystalline appearance, showed signs of freshly fractured metal.

As set forth in the evidence given by Sir John Wolfe Barry, Sir Benjamin Baker, and Mr. Kirkaldy, there can be no doubt that the fracture occurred at a weld in the bar; that the core of the bar B had never united, and had never possessed any value to resist tension; that the surfaces of the area C had united, probably indifferently, except in the immediate neighbourhood of the circumference; and that the flaw, which originated in central pocket B, had gradually extended outwards over the area C under the severe tensional stress to which (owing to the want of union in the centre) the bar had been so long subjected. The isolated bright spots and specks over the area C show that immediately before the bar snapped there was good metallic contact at these various points, as well as over the whole area A.

The total area of metal which was doing work, in resisting tension, at the moment when the bar broke may be roughly estimated at about one third of the whole area, or from 5 to 6 square inches. The total calculated stress (*see* table of stresses in Appendix), in tension was 81.5 tons, or from 13 to 16 tons per square inch of available metal. Taking into consideration the eccentric position of the bulk of the available area A, it will be admitted that so high a stress would be certain to cause rupture the moment the thread-like points of contact in the area C parted.

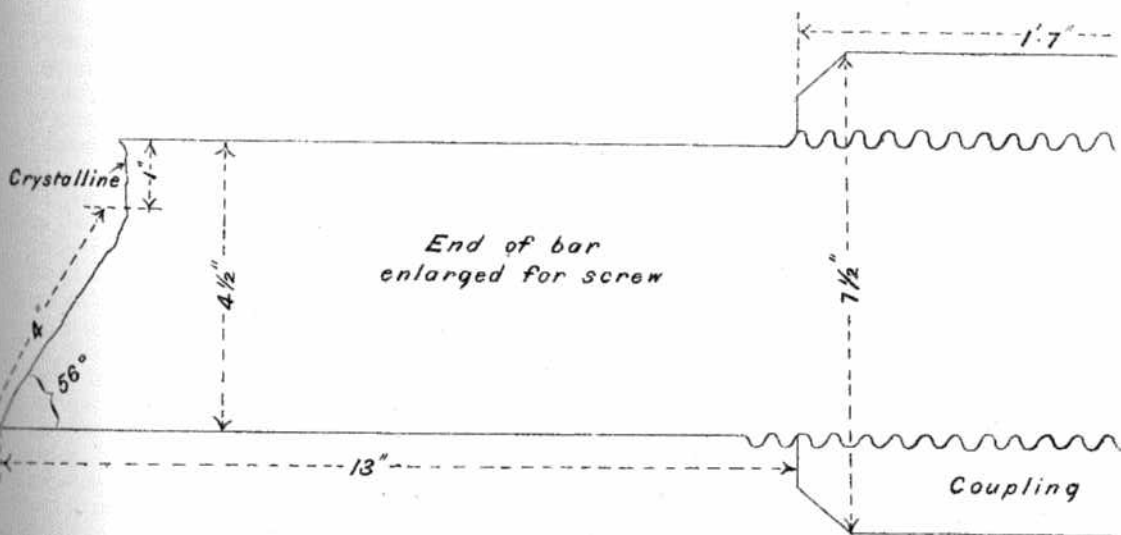
LONGITUDINAL SECTION OF FRACTURED TIE ROD.

I come to the conclusion, therefore, that the fall of the roof was brought about by the breaking of the tie-rod in the third panel from the west of the main principal nearest to the wind-screen. The fracture occurred at a weld, by reason of a flaw in the welding. This flaw, commencing in the heart of the bar, had gradually extended outwards. The additional weight of the temporary staging was the immediate cause of failure, but as the total stress in tension, at the time of failure, on the whole sectional area of the bar did not exceed 5.13 tons per square inch, I find that, for the necessary purposes of repair, such a stress was not in any way unreasonable, and could not be anticipated to cause danger of failure. Lastly, I do not consider that any reasonable precautions were neglected by the engineer or his staff in charge of the roof, or that it was possible by any practicable method to have discovered the flaw in the tie-bar.
