SOUTH-EASTERN AND CHATHAM RAILWAY.

Board of Trade, Railway Department,
8, Richmond Terrace, Whitehall, London, S.W.,
25th March, 1906.

I HAVE the honour to report, for the information of the Board of Trade, in accordance with the Order of the 6th December, 1905, the result of my inquiry into the circumstances attending the fall of part of the roof of Charing Cross Station, on the South-Eastern and Chatham Railway. The fall occurred about 3.45 p.m. on the 5th December last.

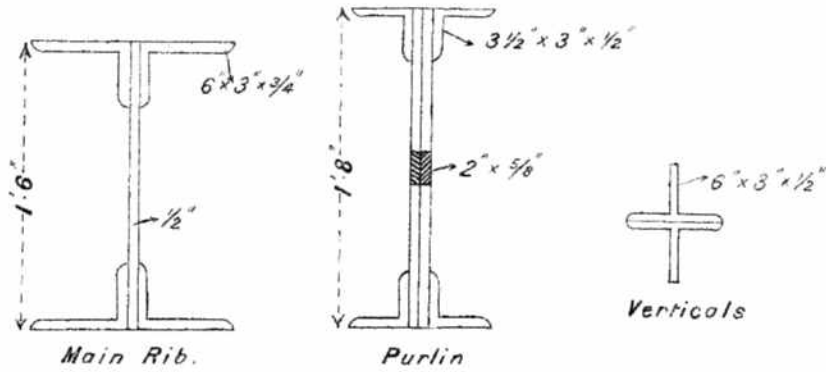
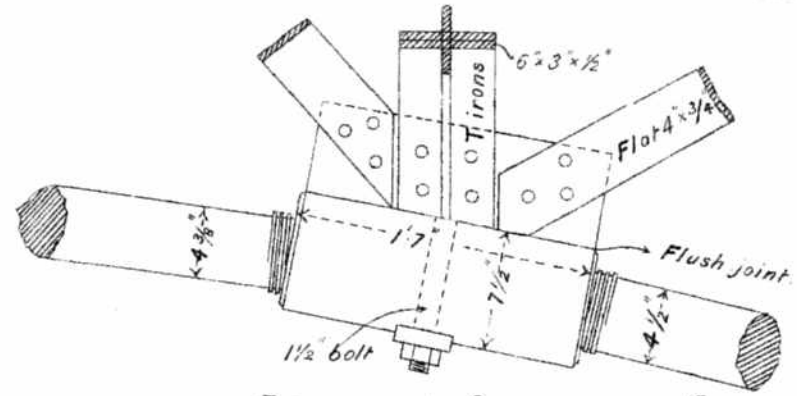
SECTIONS OF IRONWORK

Sketches of the principal which fell, and of the fractured tie bar, will be found on Plates I and II, and a table of stresses in the Appendix to the Report.
